Customer information on the use of the Petzl CROLL B16 & B16AAA in corrosive environments

April 17, 2014

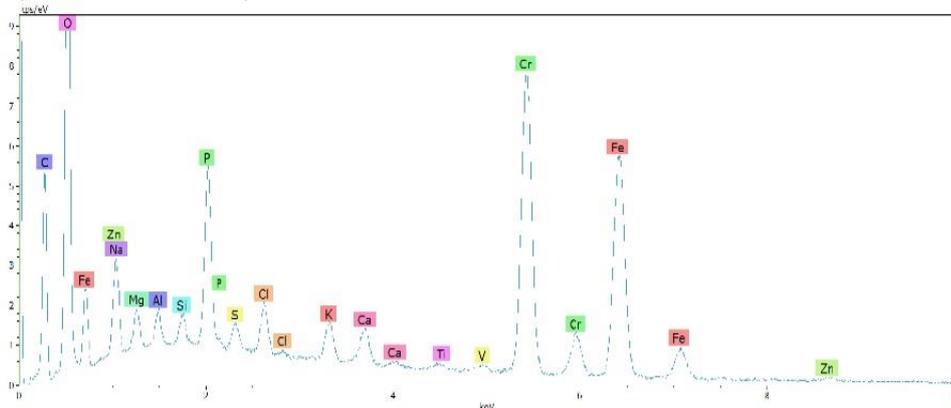
Results: In addition to the steel elements (C+Fe+Cr), we observed the presence of calcium (Ca), magnesium (Mg), sodium (Na), and chlorine (Cl) (all present in salt water) from the work environment.

(Chemical analysis of the broken rivet)

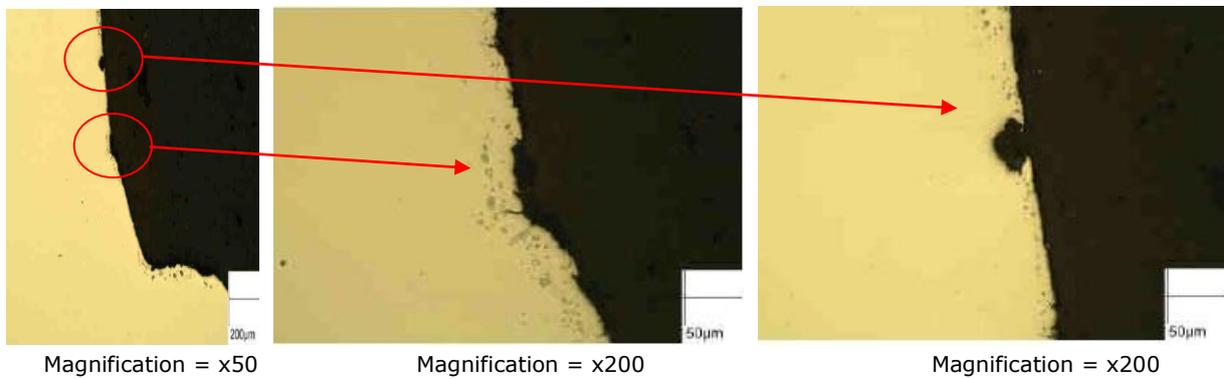
Procedure: Micrographic observations in the longitudinal axis of the rivet. Magnification from x50 to x200.
Results: Corrosion pitting is visible all along the body of the rivet.

(Micrographic images of the broken rivet show corrosion cracks)

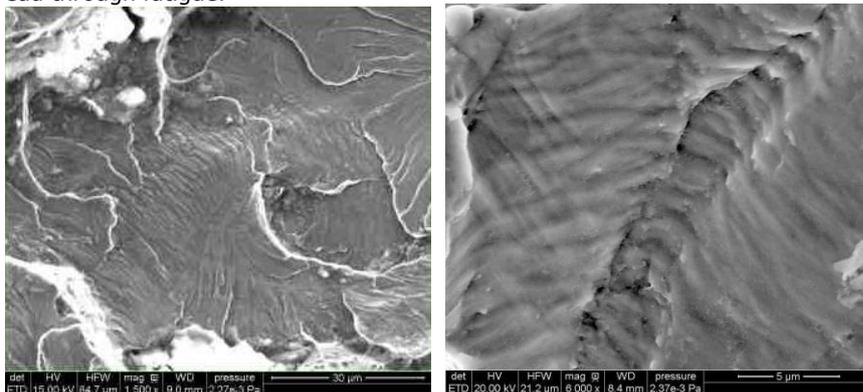
Results: We observed the presence of fatigue crack propagation.

As with any CROLL-type device, during each stroke, sudden dynamic loading is produced when the user's body weight is applied to the rope clamp. On other rope clamps, like an ASCENSION, the loading is more gradual. This sudden dynamic loading in combination with the "yo-yo" effect can lead to dynamic forces of up to 2.5 kN. The rope clamp is subjected to cyclic loading ranging from 0 kN to 2.5 kN. The combination of this cyclic loading and the corrosion pitting led to an initial fracture surface typical of cracks that spread through fatigue.

(S.E.M. images of the fracture surface show fatigue crack propagation)

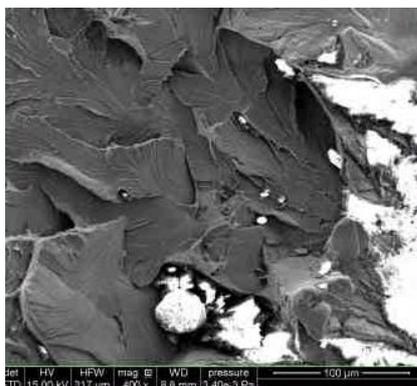
Results: Examination revealed the kind of cleavage faces that are a characteristic feature of brittle failure mode.

This also confirms the sudden nature of the failure. About two thirds of the breaking surface show a perfectly "smooth" cleavage associated with secondary cracks, and denote brittleness in fracture. We can conclude that the final failure was due to a sudden overloading of the already damaged rivet.

(S.E.M. image of the fracture surface shows the kind of cleavage faces that are a characteristic feature of brittle failure mode)

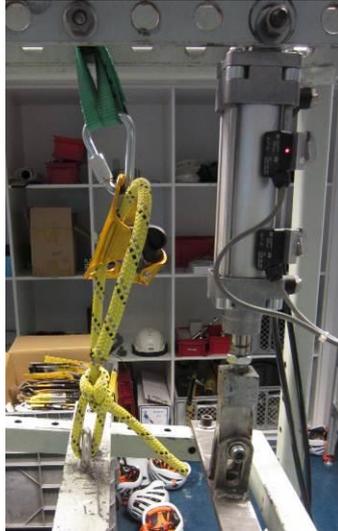
Results: The CROLL body fails before any damage to the rivet is observed. To date, it has not been possible to replicate the two failures observed in the field.

(Cyclic loading tests with a 100 kg mass)
